Information on the change of torque for screws of the ONE-SIXTY and ONE-FORTY

19.06.2023

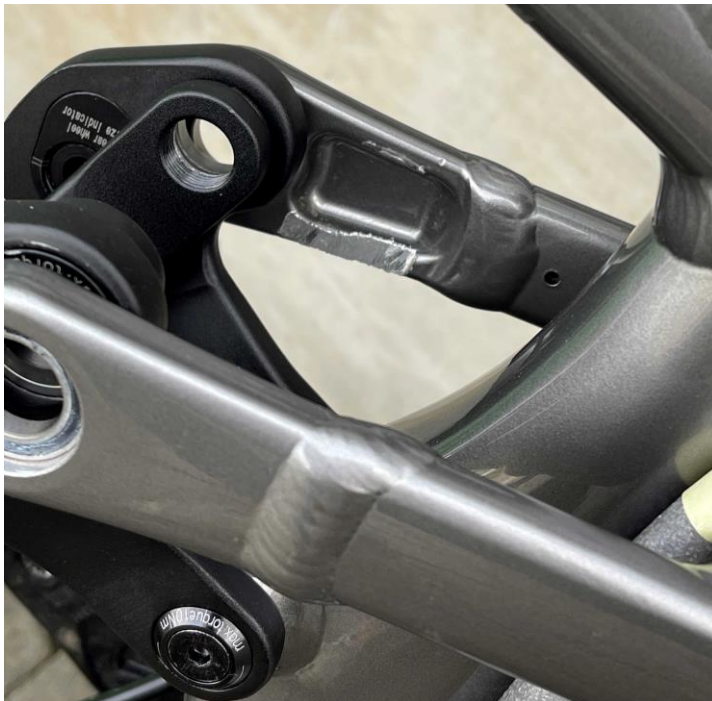
Due to insufficient torque in mass production, the screw that connects the rocker to the shock extension can come loose. Loosening this screw can damage the paint on the inside of the seat stays (see pictures below).

Please inform your dealers via E-Mail or your B2B portal that they have to increase the torque of the rocker on the delivered bikes to 23-25 Nm. Please create an awareness that the dealers and final customers check these screws and the brake mount screws from time to time.

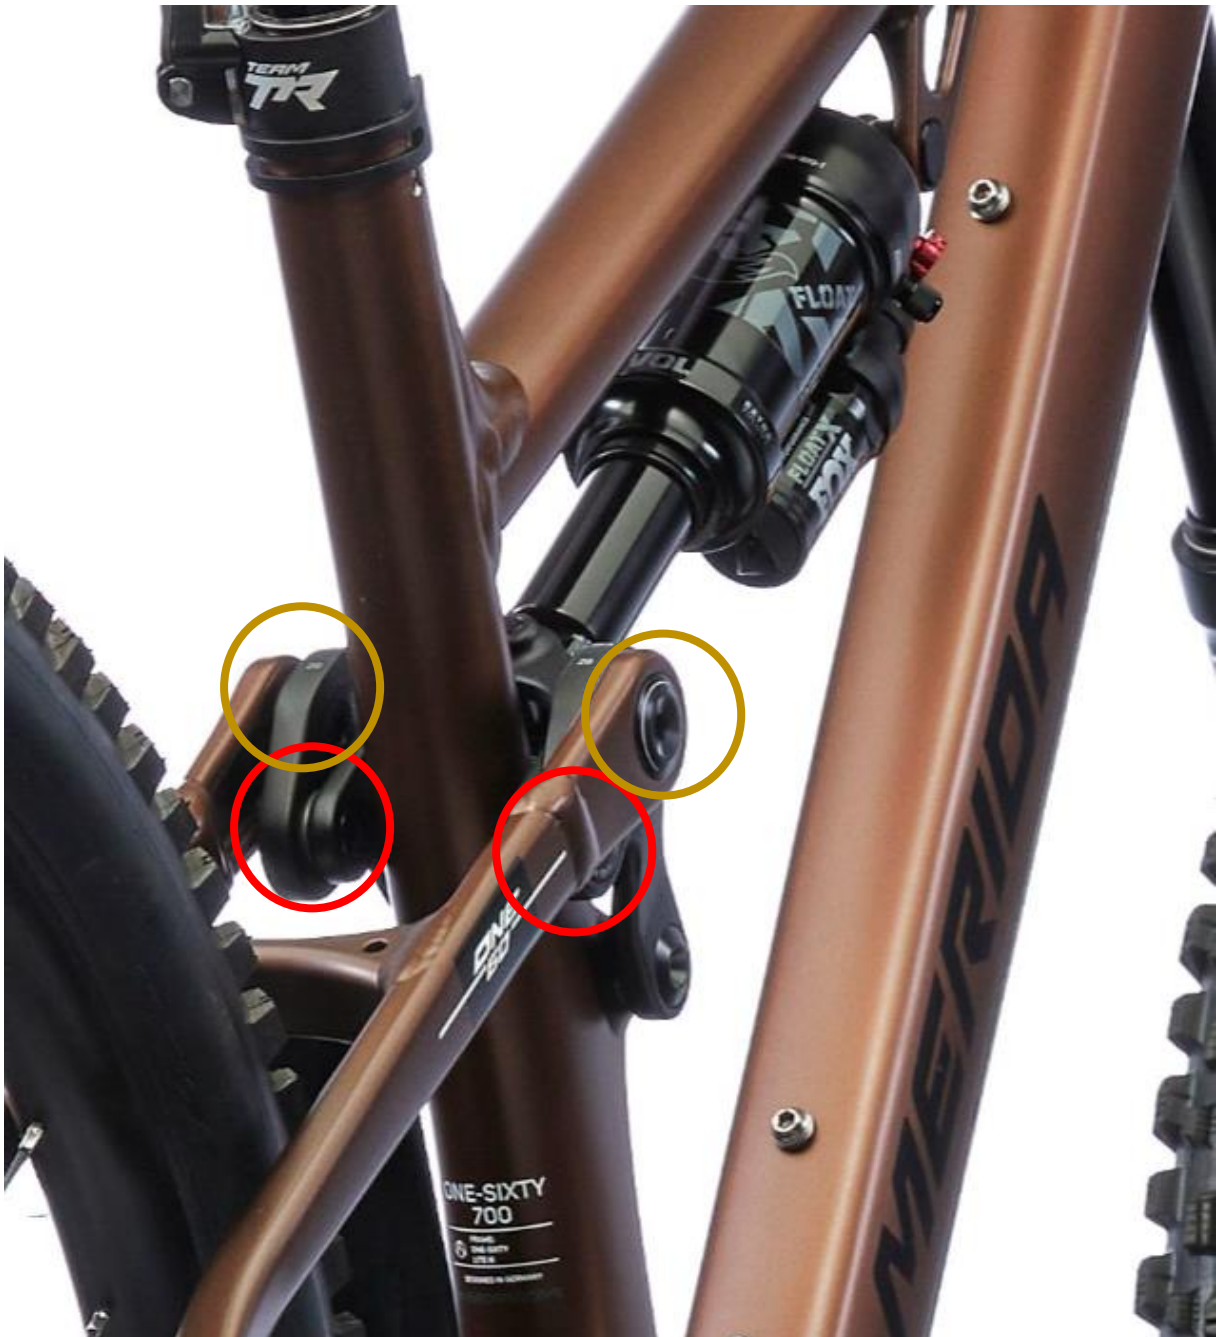
The torque of the screws which connect the rocker with the shock extension (highlighted red below, Nr. 10 [explosion drawing](#)) will be changed from 13-15 Nm to **23-25 Nm**.

Also, the torque of the screws, which connect the seat stay with the rocker (highlighted yellow below, Nr. 17 in the [explosion drawing](#)) will be changed from 13-15 Nm to **23-25 Nm**.

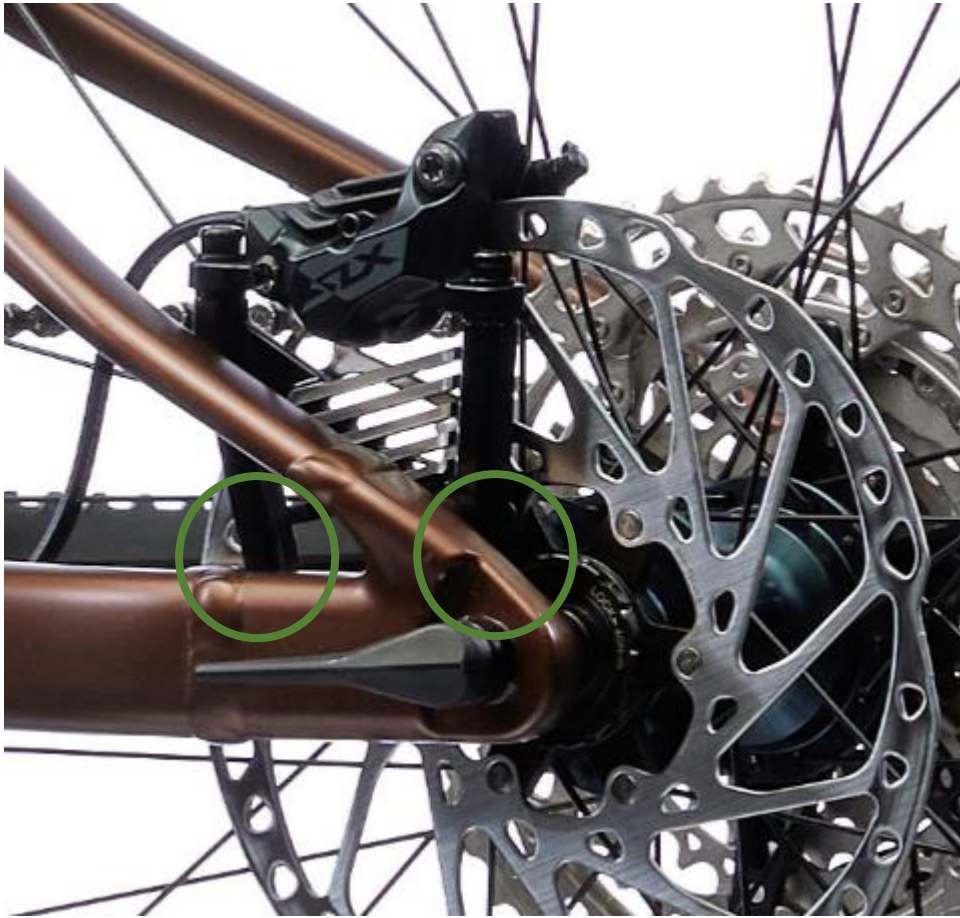
Please also note, that we have increased the torque recommendation of the three brake adapter screws (marked green below, Nr. 17 in the [explosion drawing on the right side](#)) from 6-8 Nm to 11-12 Nm.
