CUSTOMER SERVICE TECHNICAL BULLETIN

Please take the time to review the information below in regards to the MY20 and MY21 Sight carbon bikes that have been somewhat prone to lower shock bolt failure.

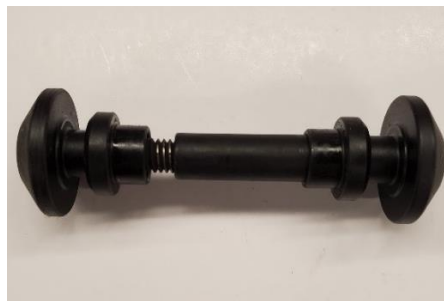
Many of you are already aware of the hardware issue faced here. It has mostly been a problem with bikes using Rockshox but has also affected a smaller # of Fox equipped bikes too. The oem hardware is undersized and can bend under hard riding.

Old hardware consists of 2 shafts and 2 reducing top hats

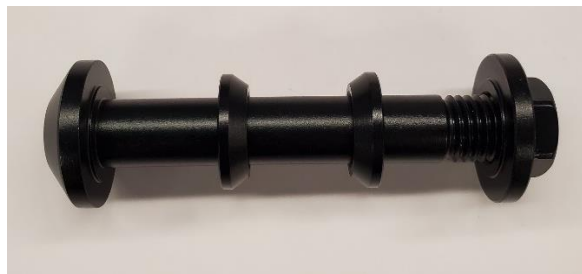
New hardware is a solid 10mm thru shaft with 2 spacers and a fixing nut

The engineering team has designed new hardware to correct this.

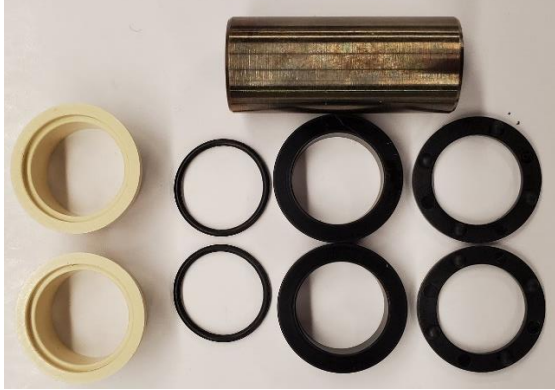
Fox equipped bikes will use 1set 913800-034

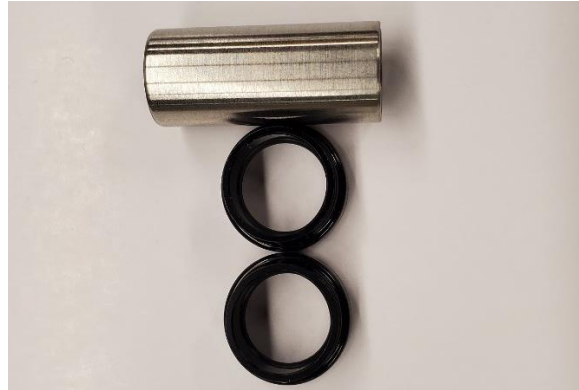
Rockshox equipped bikes will use 1set 913800-035
