Full Speed Ahead (FSA) Gossamer Pro AGX+ CK-6037 crankset Recall

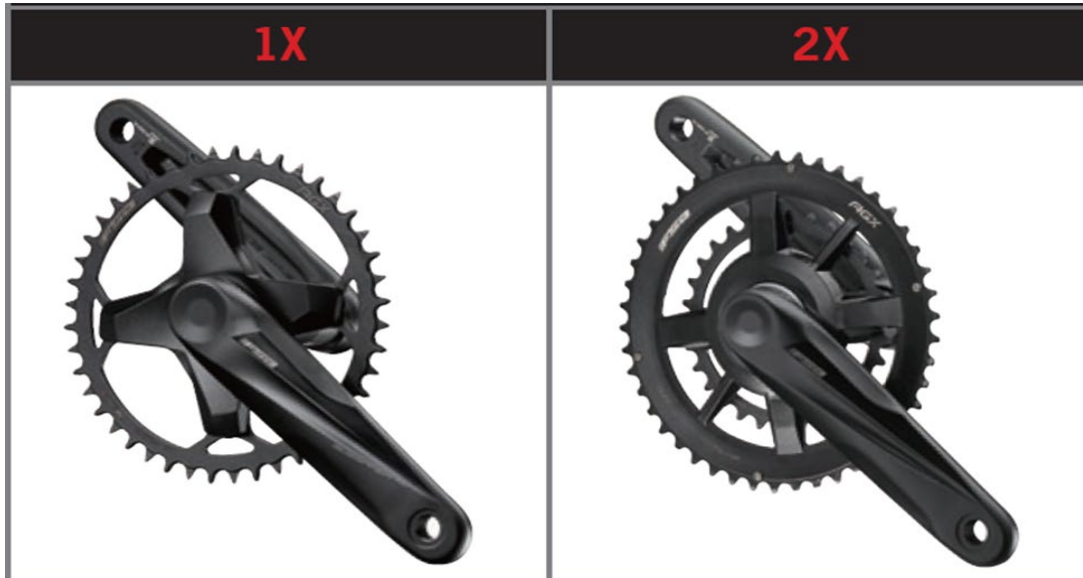
Full Speed Ahead (FSA) has received reports of crank arms becoming loose or “wobbly” and detaching from the crank/spindle, posing fall and injury hazards to consumers. Only the drive-side crank arm is susceptible to bonding failure. Consumers should immediately stop using the bicycles with the recalled cranksets and contact Full Speed Ahead for instructions on how to receive free dealer installation of a new replacement crankset.

FSA is preparing to replace cranksets for consumers, dealers, distributors, and bicycle manufacturers (referred to as OEM) with the Gossamer Pro AGX+ CK-6037 cranksets. FSA will be requesting all cranksets within serial number ranges starting with **B1, B2 and B3** to be returned to FSA for replacement. Shipping costs associated with returning the cranksets will be paid by FSA, please contact your FSA representative for specific details.

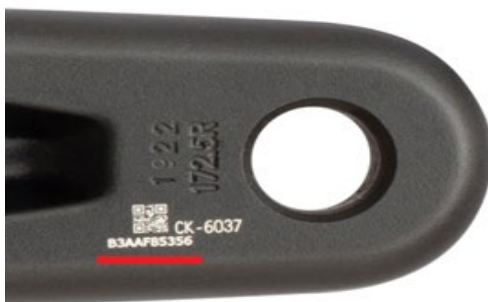
Inspect Gossamer Pro AGX+ CK-6037 cranksets and bicycles pre-assembled by OEM with Gossamer Pro AGX+ CK-6037 cranksets that may be within the serial number range stated below. FSA will be requesting all cranksets within serial number ranges starting with B1, B2, and B3 to be returned to FSA for replacement. The serial number range is shown highlighted below. The cranksets were sold on Cannondale, Canyon, Marin Haro, Fuji and Pinarello gravel brand bicycles.
