DISTRIBUTOR NON-COMPLIANCE BULLETIN

Please take note of a non-compliance issue with our Sight VLT 29 carbon and aluminium bikes. Some bikes may exhibit play in the lower shock mount assembly.

ISSUE IDENTIFIED

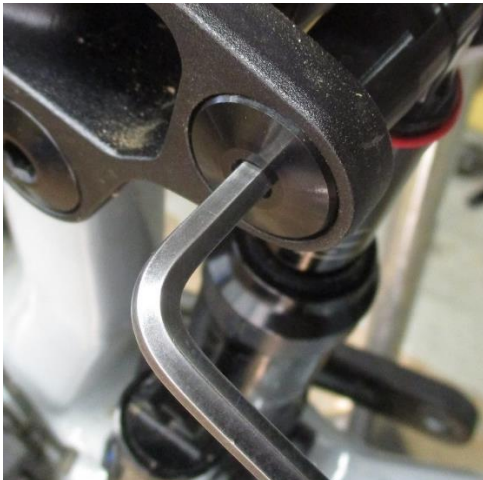
Upper shock bolts

- Remove shock from frame.

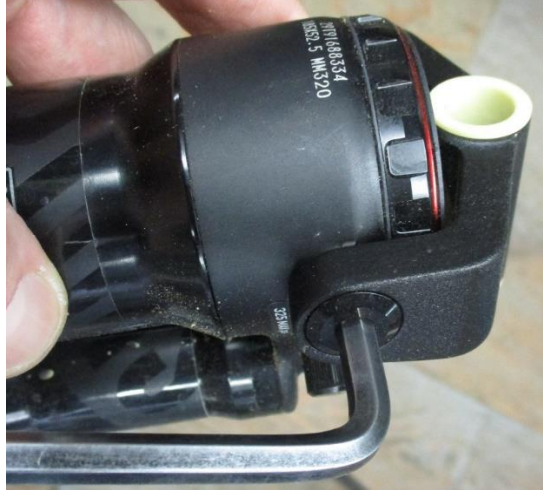
- Remove lower shock assembly from the shock.

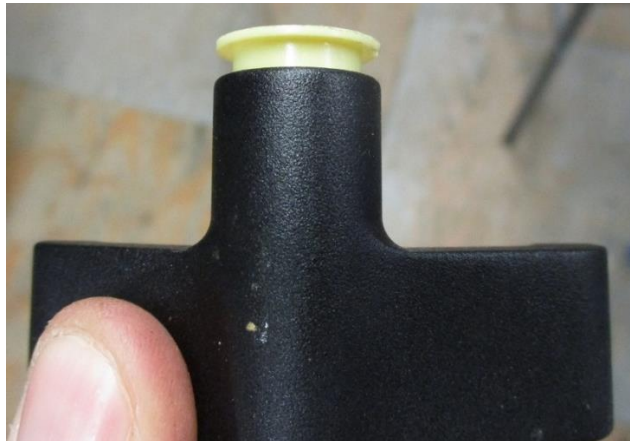
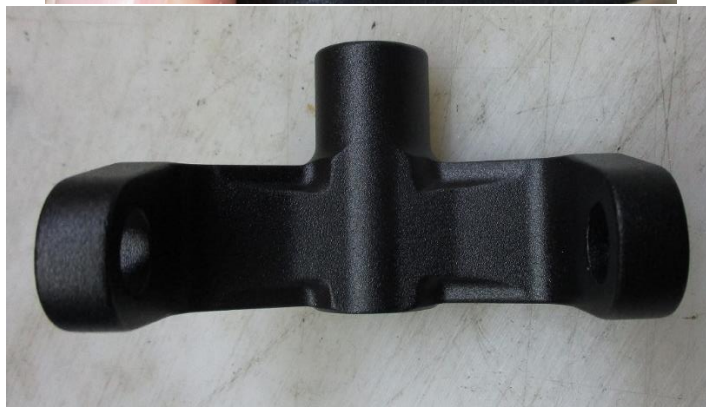
- Remove Iglas bushings from the lower assembly, both sides.
- It is possible that the original Iglas bushings can become damaged during removal. If this occurs make sure to use the new supplied Iglas bushings during installation steps.
