CUSTOMER SERVICE BULLETIN

Dropper Post Housing and Di2 Wire Unable to adjust in downtube.

2021 Indie VLT 1 Men 2021 Indie VLT 1 Step-through

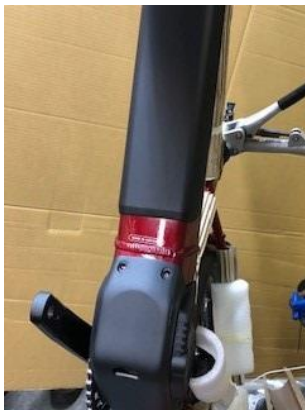
Remove battery cover
& DU cover.

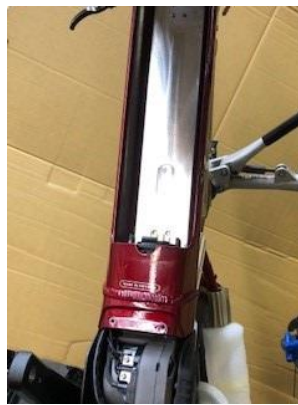
Remove battery

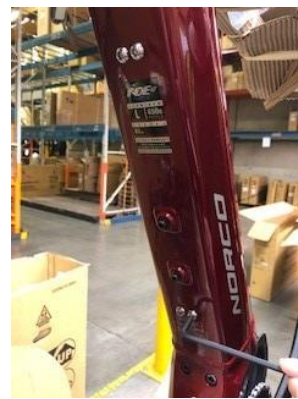
Loosen 4 bolts (3 to 5 turns)

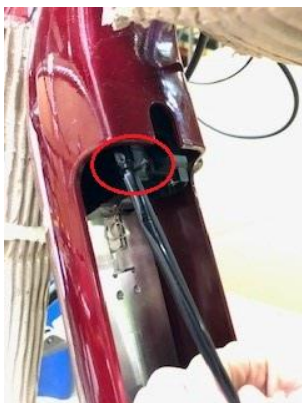
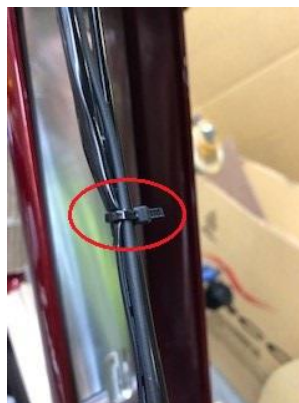
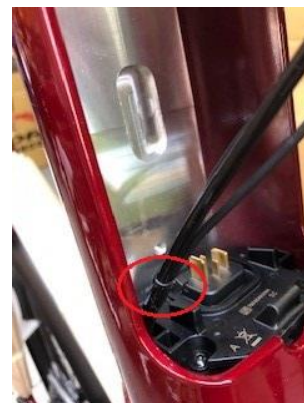
- 1 Shifter and Dropper cable housings along with the 950mm Di2 wire have been incorrectly zip-tied together inside downtube on all sizes thus the 950mm Di2 wire may appear to be too short and dropper housing cannot be adjusted to install dropper post.
- 2 The 950mm Di2 wire is long enough for the Indie VLT 1 bikes and will not reach display unit.

Locate wires at top-side of downtube and pull out and away from under battery bracket.
Locate three zipties inside downtube - top – middle – bottom
Use side cutter to cut all three zipties.

Housings and Di2 wire should move freely.
At this time adjust Dropper post housing and install dropper post.
Gently pull Di2 wire up towards headtube.

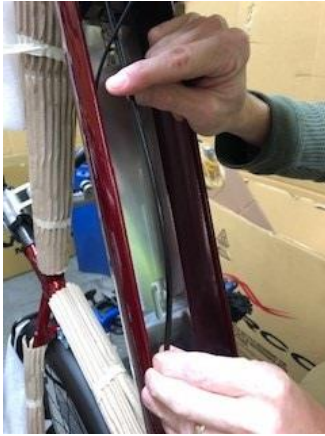
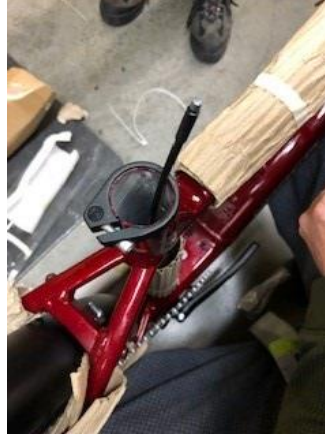
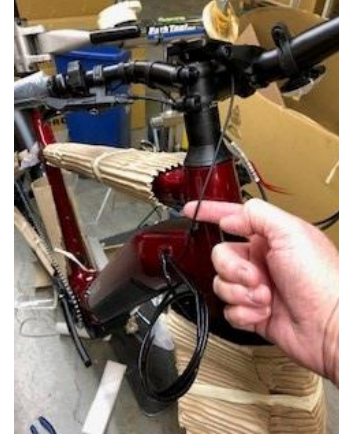
The 950mm Di2 wire will now reach Display unit (Large size shown turned 90 degrees)

Once corrective action plan has been performed if customers still have concerns regarding the Large size Indie VLT 1 Di2 wire appearing too short please contact our after sales department.

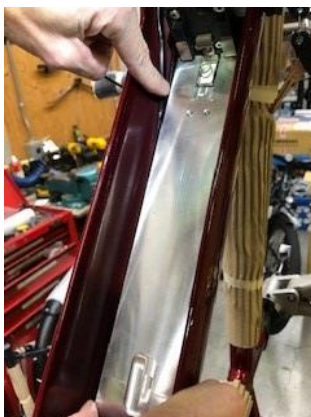
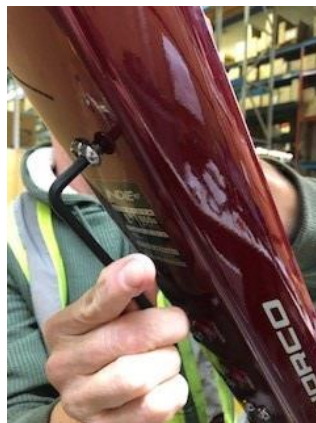
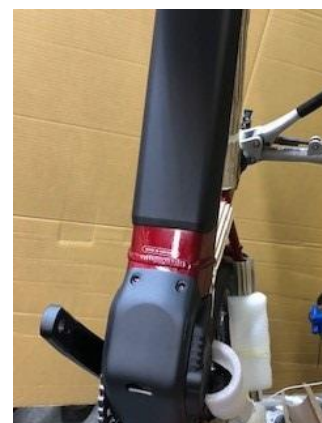
Now gently tuck housings and Di2 wire back up between toptube and battery bracket.

Reassembly note: Do Not install new zipties !

Tighten the four battery bracket bolts to 10nm

Install battery, battery cover and DU cover (DU cover bolts tighten to 5nm)
